NASA  
Technical Memorandum 105434

# Experimental Testing of Prototype Face Gears for Helicopter Transmissions

R. Handschuh and D. Lewicki  
*Propulsion Directorate*  
*U.S. Army Aviation Systems Command*  
*Lewis Research Center*  
*Cleveland, Ohio*

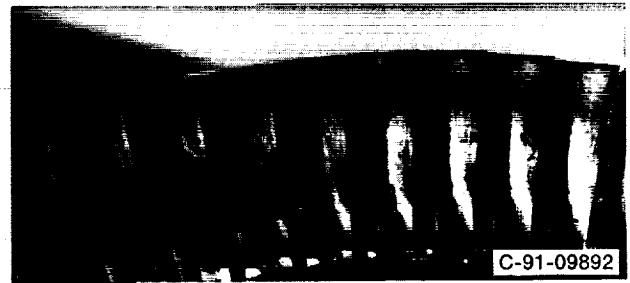
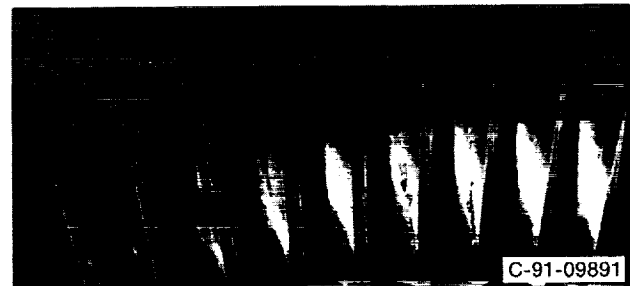
Figure 10.—Test side face gear after 30 million pinion cycles at 100 percent torque.

Figure 11.—Test side spur pinion after 30 million cycles at 200 percent torque.

Figure 12.—Slave side face gear after 30 million pinion cycles at 200 percent torque.

Figure 13.—Slave side spur pinion after 30 million cycles at 200 percent torque.

After successful completion of the first series of tests at 100 percent torque, the torque was increased in 20-percent increments until the 200-percent torque level was reached. The gears were visually inspected after 1 hr of operation at each increased level of torque for the first build (table III). The torque was increased from 100 to 200 percent load in one step for the second build (table IV). The test hardware from the first build is shown after 30 million pinion cycles at 200 percent torque in figures 10 to 13.

In the first build all hardware survived the 200 percent torque test. Slightly more wear on all members was apparent from that of the tests conducted at 100 percent torque. The pinions and the test side face gear had moderate wear and some random micropitting, but generally were in good shape for a 200-percent torque test. The slave side face gear surface distress, as previously mentioned (pit lines and micropitting), became more pronounced. However, there was no damage that would preclude further testing.
